Case No. 3:19-cv-00602-wmc

JOINT STATUS REPORT REGARDING MEANDER CONDITIONS

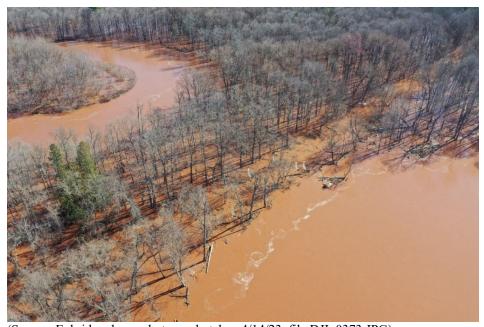
The Bad River overtopped its banks at the Meander the past two weekends. *See* **Figure 1**, below.

Figure 1. Bad River Inundation of Meander Neck, April 14, 2023 (View East).
